## Shared Learning

### Case 2018.1A: Crossed O<sub>2</sub> and N<sub>2</sub>O Gas Lines

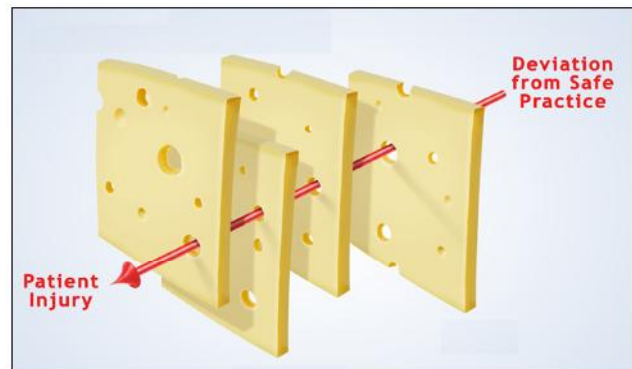
**What we learned:** The DPSF Committees are aware of several similar incidents. Building codes and enforcement of those codes vary across the United States. In this particular case, the mechanical engineers of the new building mistakenly and improperly labeled the oxygen and nitrous pipelines on the blue print drawings. The plumbing contractors, who were not certified to install medical gases, then followed the blueprints without noticing the lines had been mislabeled. The dental supply company in turn installed the manifolds and other hardware to the crossed lines without confirming their correct placement. Finally, the city building inspectors failed to take steps to assure the gas lines had been installed properly by skilled and certified installers and that proper testing had been performed. This case is another example of Reason’s Swiss Cheese Modal of Accident Causation where multiple safeguards (slices of cheese) fail (holes in slices), and seemingly minor deviations from safe practice accumulate and temporally align, thereby reaching the patient and possibly causing injury.

**Recommendations and action:** Dentists contemplating new construction or a remodel of existing space should only hire qualified contractors who are licensed and certified in their specific area of the project. Municipal building codes for medical and dental offices should be standardized in all states and practitioners should insist on an independent analysis of medical gases once construction is complete. Oxygen analyzers can be purchased for less than \$100, and a simple check can be performed by anyone familiar with the equipment. This case serves a reminder that outliers can injure patients, and that low frequency, high impact events require the same vigilance and attention to remediation as do high frequency, unsafe conditions or near misses that often do not reach the patient.
